## Test Report

FOR: **Sof Surfaces Inc.**  
Petrolia, Ontario, Canada

**Sound Transmission Loss**  
**RAL-TL18-372**

CONDUCTED: 2018-06-06  
ON: 2.75 in. thick duraSOUND over 6 in. concrete slab

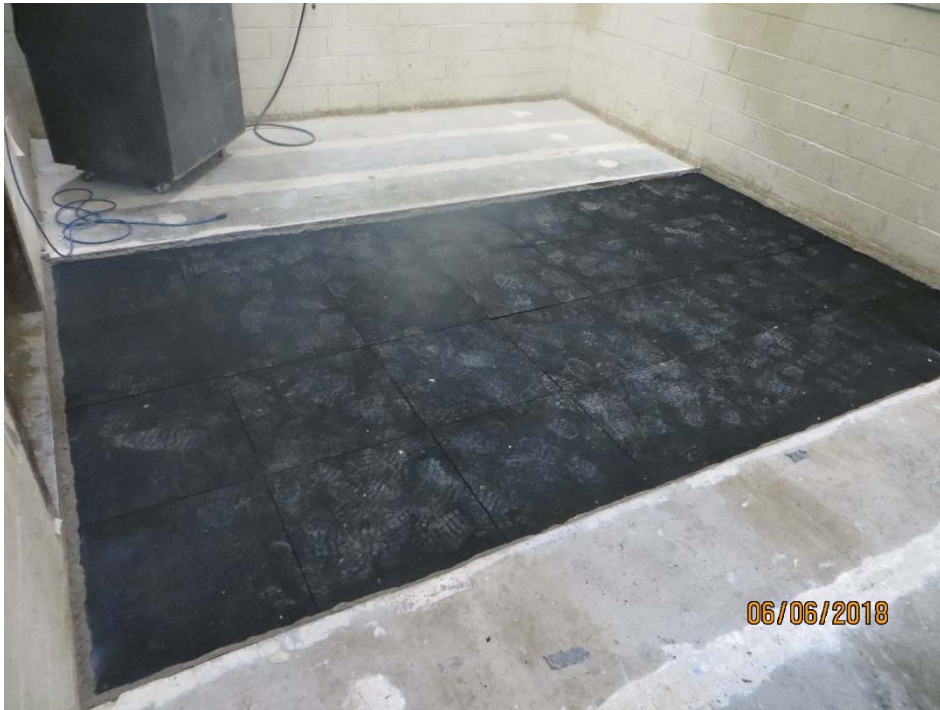
Figure 1 – Specimen mounted in test opening

The test specimen was designated by the manufacturer as 2.75 in. thick duraSOUND over 6 in. concrete slab. A full external visual inspection performed on the test specimen by Riverbank personnel verified the manufacturer's description.

Size: 4.27 m (14.0 ft) by 2.44 m (8.0 ft.)  
Filler Wall: None  
Sealed: Entire periphery (both sides) with dense mastic

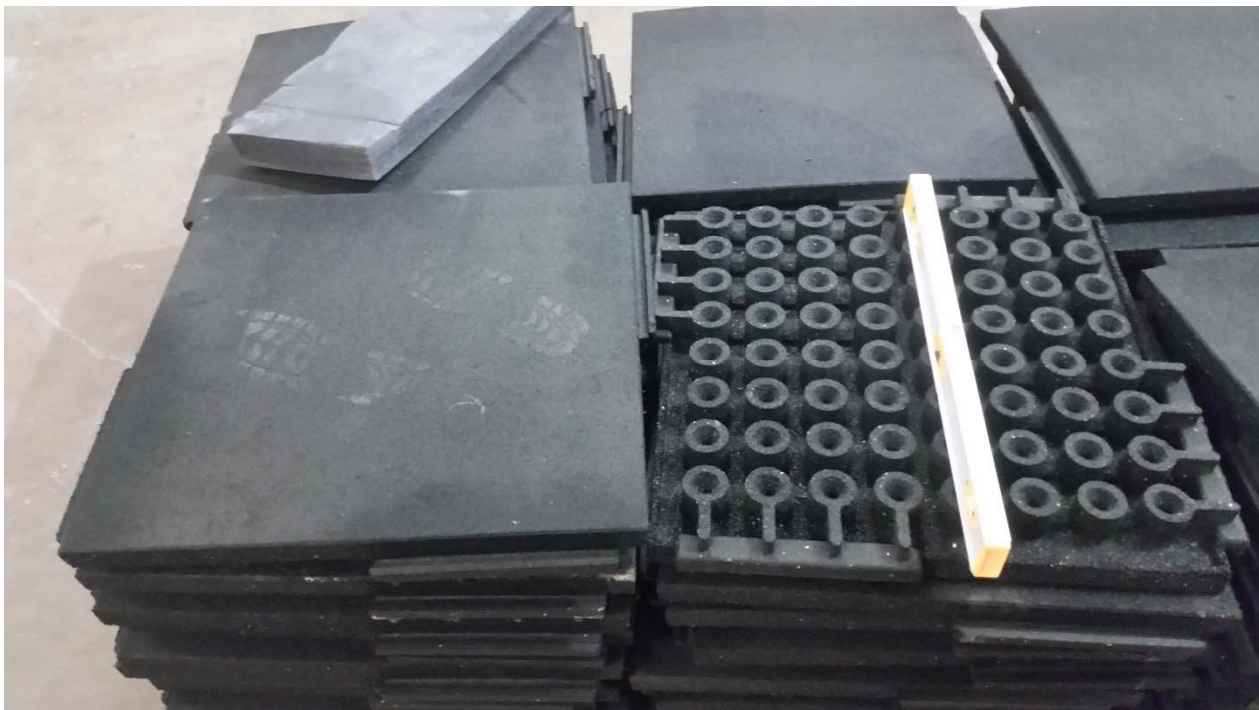
Figure 2 – duraSOUND panels

Trade Name: duraSOUND  
Material: 100 % recycled crumb rubber  
Panel Dimensions: 612.78 mm (24.125 in.) x 612.78 mm (24.125 in.)  
Overall Thickness: 69.85 mm (2.75 in.)  
Installation: Loose laid on concrete slab  
Rubber support pedestals @ 49.28 mm (1.94 in.) diameter x 31.75 mm (1.25 in.) high, placed under corners where four panels meet  
Panels held together by integrated lap joints  
Overall Weight: 399.73 kg (881.25 lbs)  
Mass per Unit Area: 38.42 kg/m<sup>2</sup> (7.87 lb/ft<sup>2</sup>)

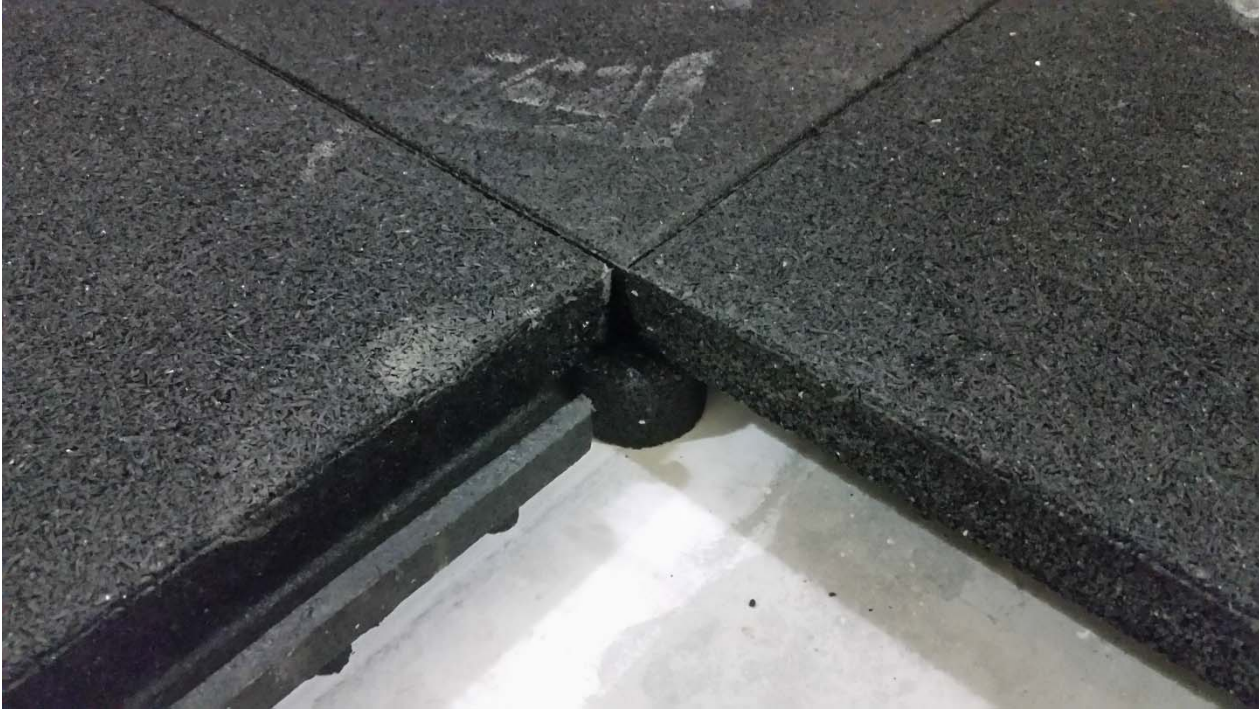
Figure 3 – Typical support pedestal installation

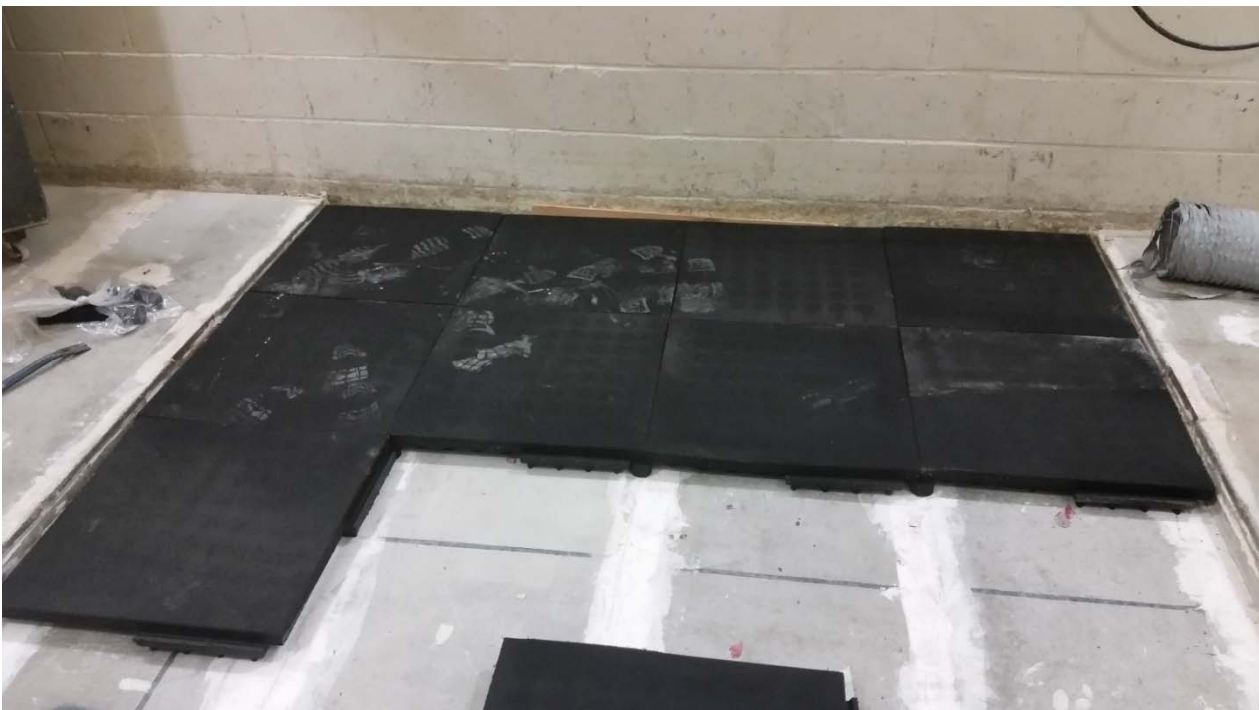
Figure 4 – Flooring partially installed
