## Test Report

FOR: **Sof Surfaces Inc.**  
Petrolia, Ontario, Canada

**Sound Transmission Loss**  
**RAL-TL18-376**

ON: 3.25 in. thick duraSOUND over 6 in. concrete slab

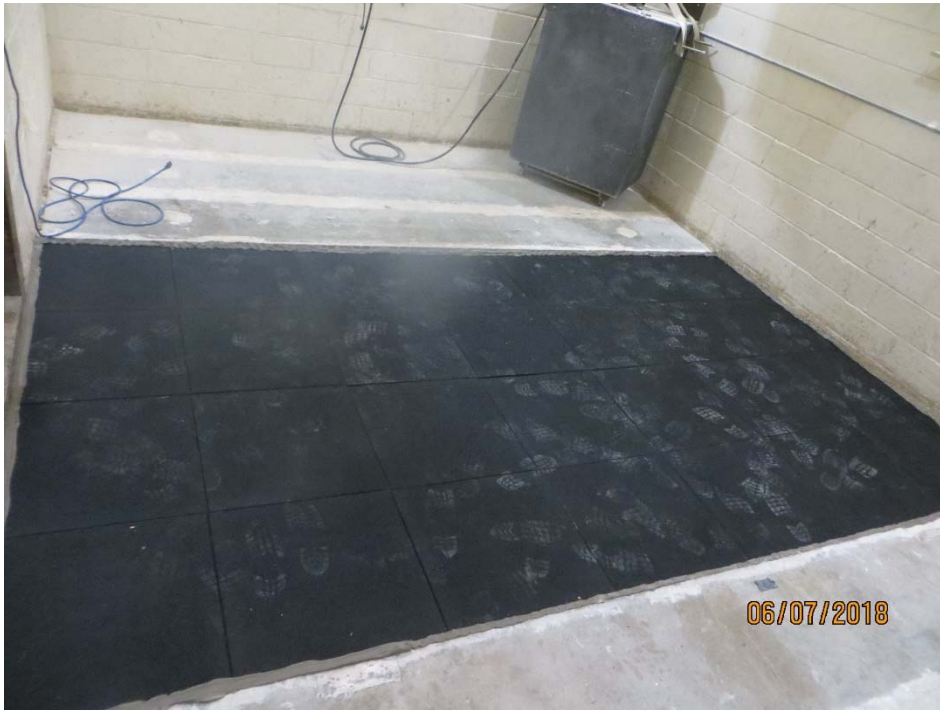
Figure 1 – Specimen mounted in the test opening.

The test specimen was designated by the manufacturer as 3.25 in. thick duraSOUND over 6 in. concrete slab. A full external visual inspection performed on the test specimen by Riverbank personnel verified the manufacturer's description.

Size: 4.27 m (14.0 ft) x 2.44 m (8.0 ft.)  
Filler Wall: None  
Sealed: Entire periphery (both sides) with dense mastic

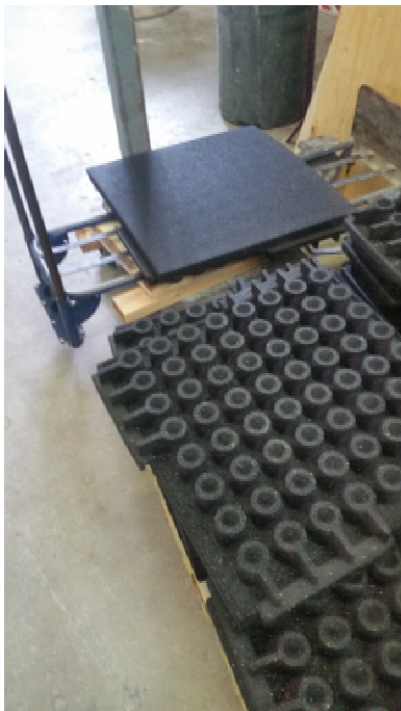
Figure 2 – Individual duraSOUND panels

Trade Name: duraSOUND  
Material: 100 % recycled crumb rubber  
Panel Dimensions: 612.78 mm (24.125 in.) x 612.78 mm (24.125 in.)  
Overall Thickness: 82.55 mm (3.25 in.)  
Installation: Loose laid on concrete slab  
Rubber support pedestals @ 49.28 mm (1.94 in.) diameter x 45.97 mm (1.81 in.) high, placed under corners where four panels meet  
Panels held together by integrated lap joints  
Overall Weight: 429.89 kg (947.75 lbs)  
Mass per Unit Area: 41.32 kg/m<sup>2</sup> (8.46 lb/ft<sup>2</sup>)

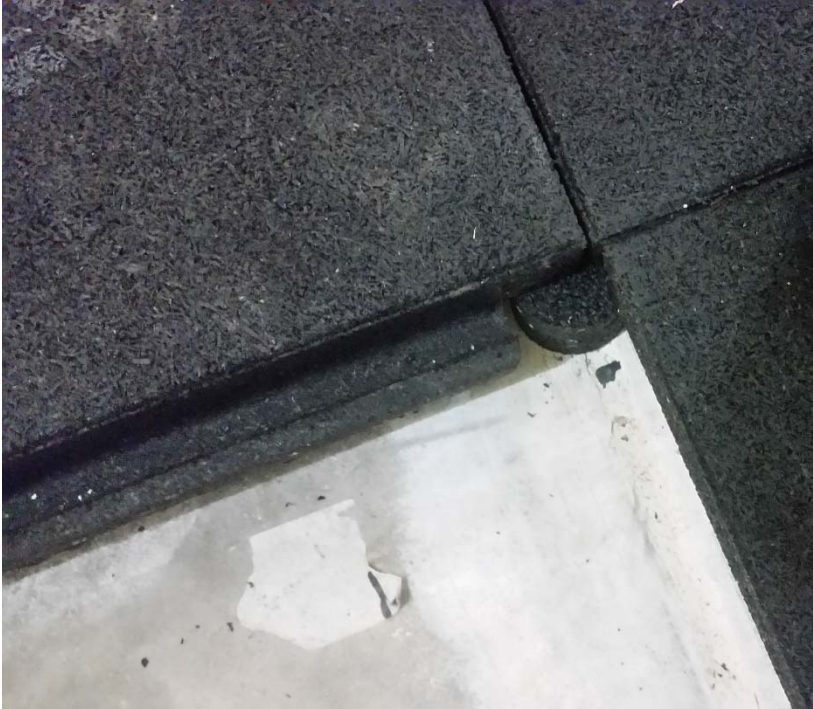
Figure 3 – Typical support pedestal installation
